FIELD STUDY REPORT

*Submitted to the University of Kerala in partial fulfillment of award of the Degree
of Master of Science in Zoology*

CONTENTS

Sl. No	Title	Page No.
1	FIELD VISIT TO ASHTAMUDY ESTUARY	1 – 39
2	POLLUTION STUDY OF SASTHAMKOTTA	40 - 78

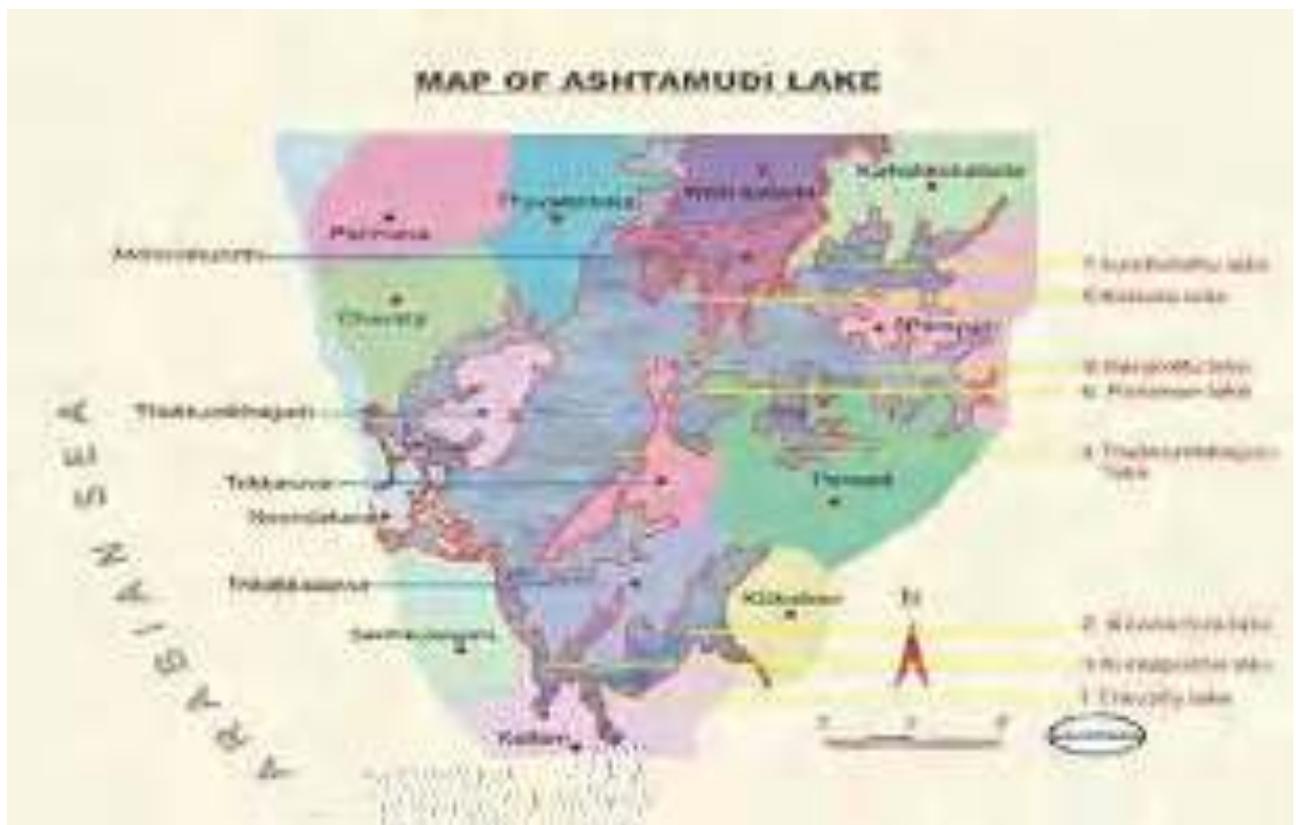
The Ashtamudi Lake in the Kollam district lies in between 76.53° and 76.63° longitude and 8.93° and 8.83° latitude. It is a palm-shaped extensive water body with eight prominent arms, adjoining the Kollam town. This extensive estuarine system has a length of 16 km with a maximum width of 14 km and maximum depth up to 6.4m covering an area of 64.2 km^2 . It is surrounded by lush green trees and swaying coconut palms. This 16 km long lake is the second largest lake in Kerala, which has found its way into the sea through the Neendakara estuary. It is because of its eight 'arms' or channels, that the lake is named Ashtamudi. The eight different branches of Ashtamudi each have different names. They are Thevally Lake, Kandachira Lake, Kureepuzha Lake, Thekkumbagham Lake, Kallada Lake, Perumon Lake, Kumbalathu Lake and Kanjirottu Lake. The study was conducted on 8th October 2021.

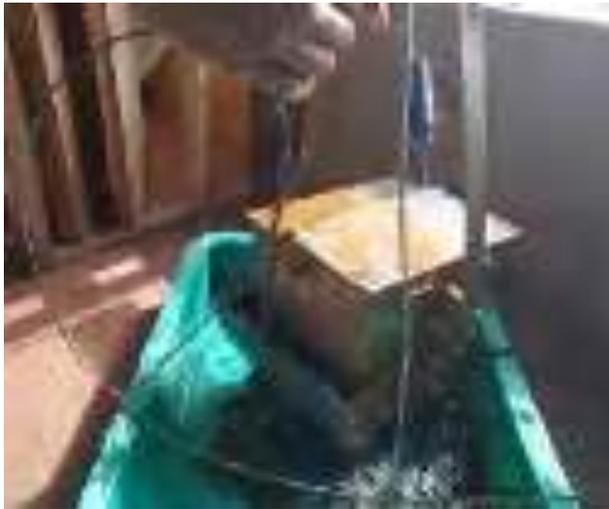
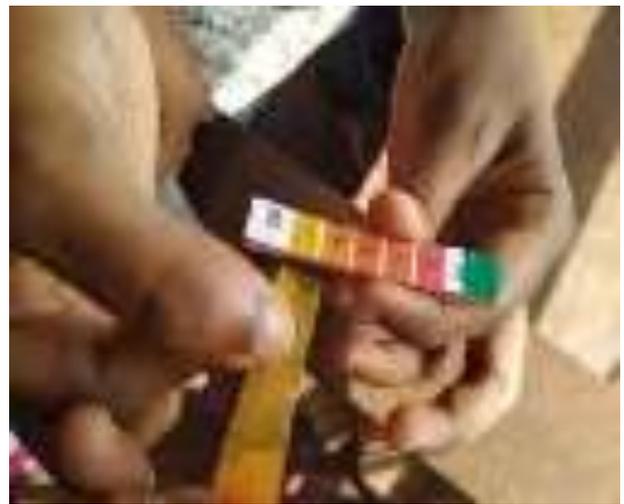
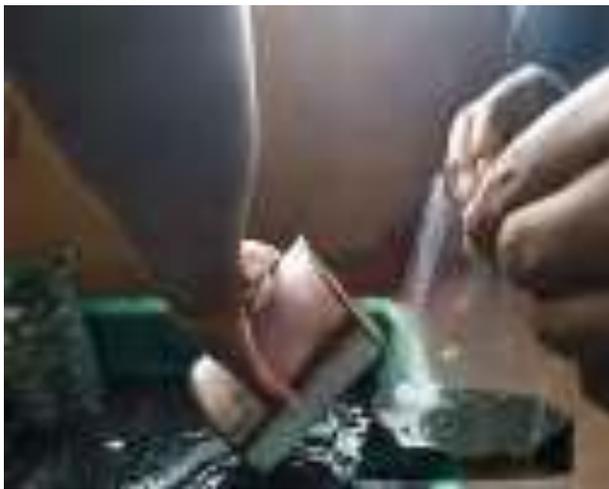
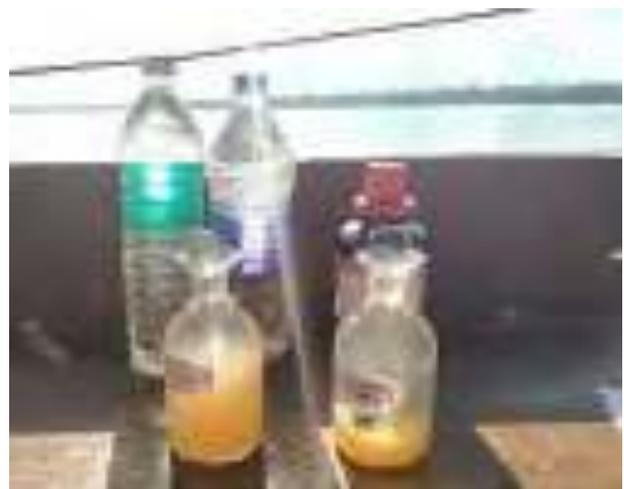
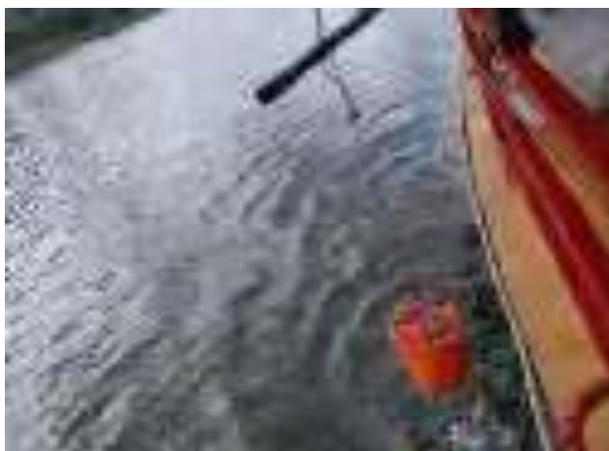
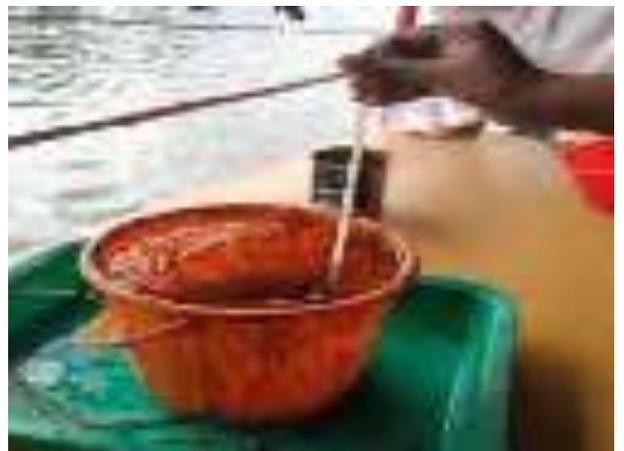
The samples were taken from 15 stations of Ashtamudi lake. The collections were made during the day time. Surface water samples were collected using clean bucket. Samples were stored and preserved as per APHA standards. Water samples were stored in pre-rinsed plastic bottles and analysis were done on the next day itself.

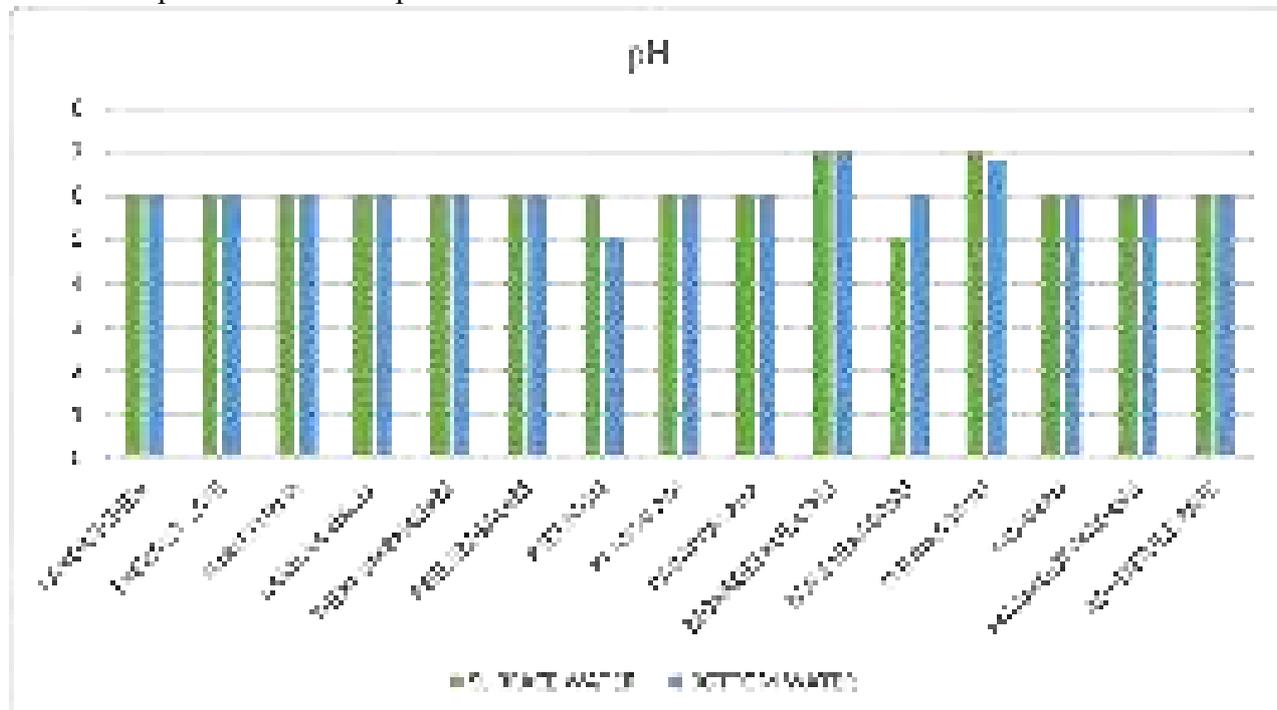
1) pH

pH pH is one of important parameter for water quality which indicates hydrogen ion concentration in water. pH is a scale of intensity of acidity or alkalinity and measures the concentration hydrogen ions in water. pH of natural water varies around seven (6 to 7). A lower pH value below 4 produces sour taste and high value, above 8.5 a bitter taste. Present results reveal with the pH ranges between 5 and 7. The lowest PH value is noted down from the analysis of the bottom sample of S7 (Perumon) and the surface sample analysis of S11 (Malayilkadavu). Lowering of pH might be due to stagnation, decay of vegetable matters, discharge of domestic sewage and increase of carbon dioxide. Station S1 (Kandachira lake) had shown the highest pH among all the stations. The PH of the sediment taken from various other stations also ranges in between 6 and 7.

Graph 1: Variation of pH in different stations of Astamudi lake

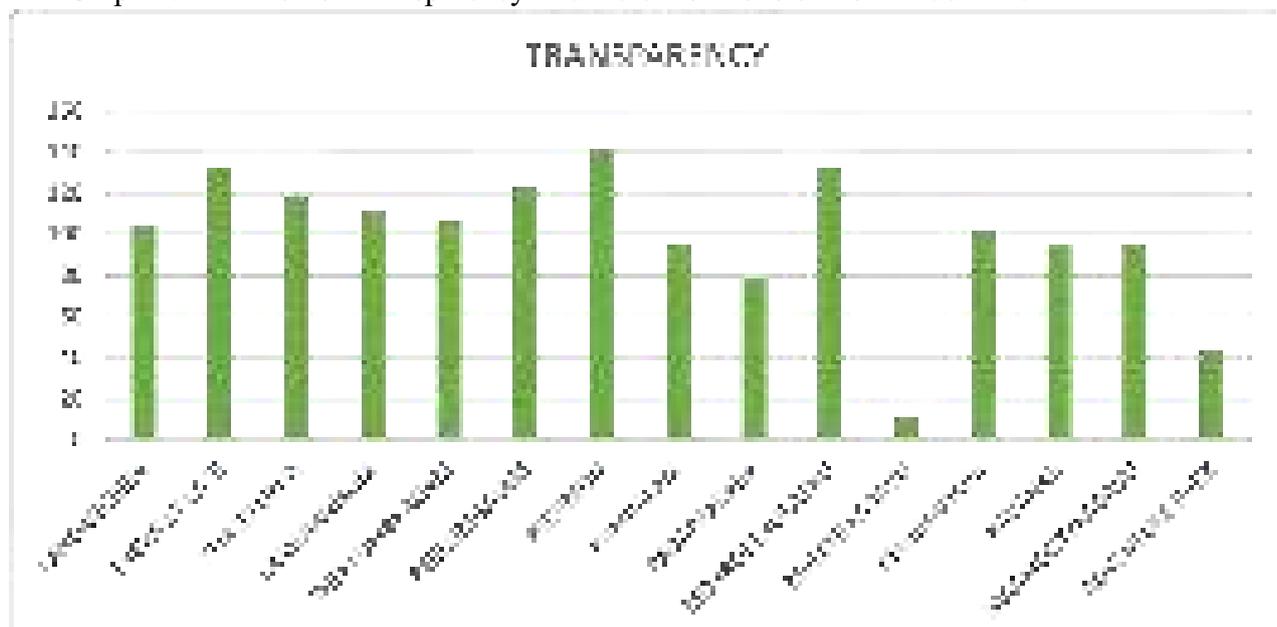
(2) TRANSPARENCY

Transparency is a water quality characteristics of water bodies which varies with the combined effects of colour and turbidity. The secchi disc visibility showed wide variations at different stations of the Ashtamudi Lake. Transparency value is found to be relatively high (133cm) at S10 (Monroethuruth) and the minimum transparency value (43.5cm) has been noted down at S15 (Adventure park).

Graph 2: Variation of Transparency in different stations of Ashtamudi lake

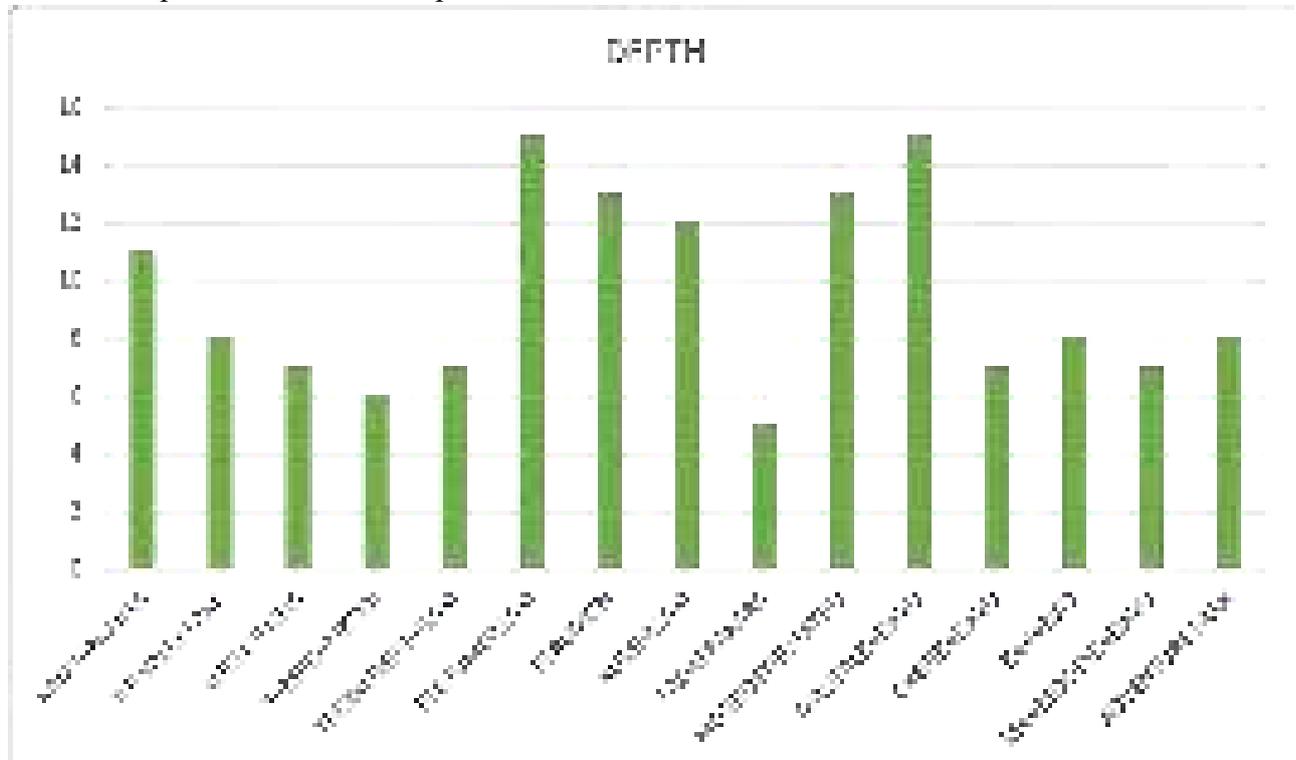
(3) DEPTH

Depth of Ashtamudi Lake showed marked variations from one station to another. Depth at stations S6 and S11 (Perungalam and Malayilkadavu) was observed to be the maximum, which is about 15 feet. The station S4 (Sambranikodi) is the area which is having the minimum depth of about 6 feet. The depth of all other stations ranges in between 7 and 13 feet.

Graph 3: Variation of Depth in different stations of Ashtamudi lake

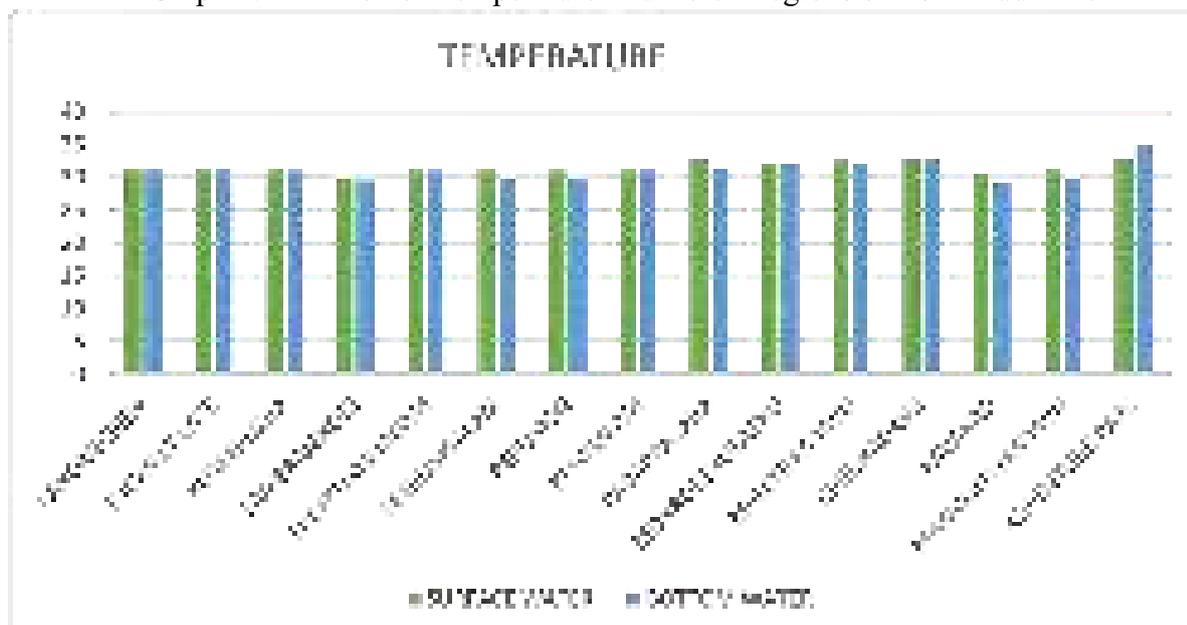
(4) TEMPERATURE

Temperature is a crucial water quality parameter which regulates the maximum dissolved oxygen concentration. In the present study, atmospheric temperature and also the temperature of both, bottom and surface samples are noted down. The atmospheric temperature is very high at S1 (Kandachira lake) (32 degree Celsius) and it was found to be comparatively low at S12 (Cherikadavu) (27.5 degree Celsius). Analysis showed that, the temperature noted down is comparatively high in case of the surface sample of the station S15 (Adventure park). A Temperature of about 29 degree Celsius has been noted down on analysing the bottom sample of station S13, which is the lowest temperature experienced among all the stations.

Graph 4: Variation of Temperature in different regions of Ashtamudi lake

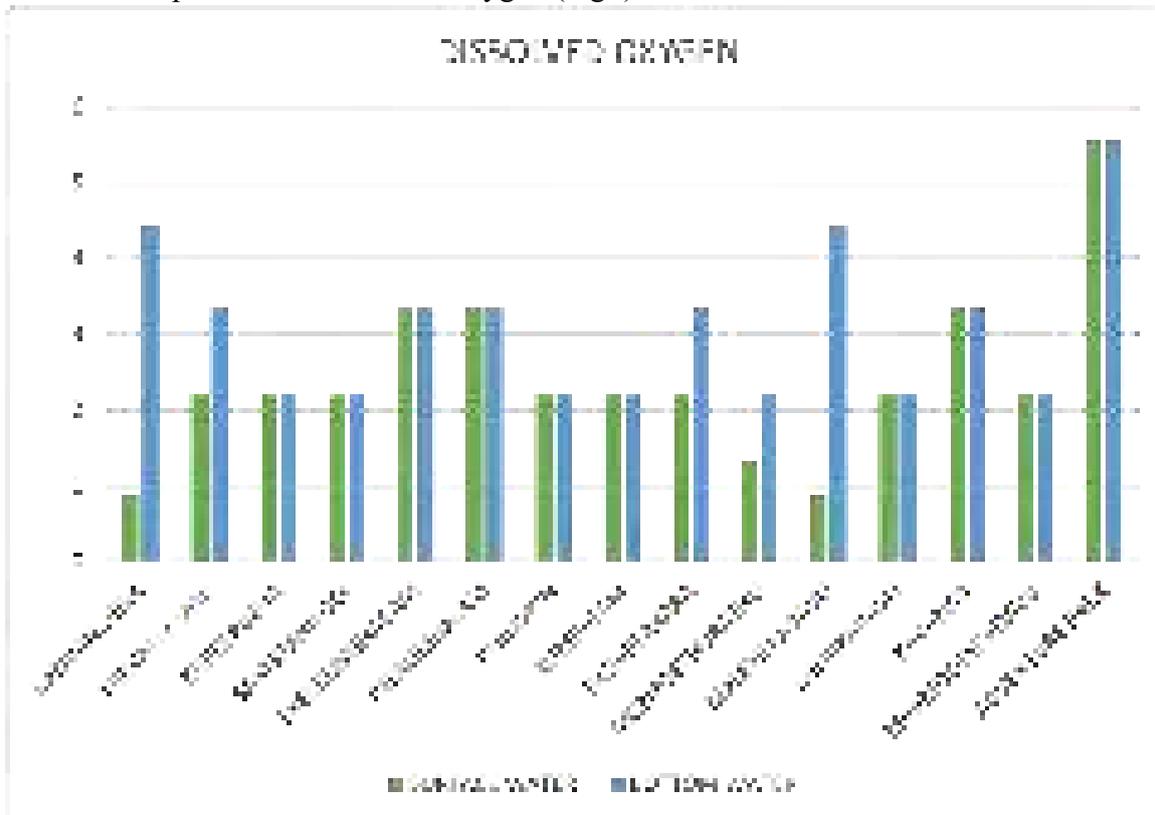
(5) DISSOLVED OXYGEN

Graph 5: Total dissolved oxygen (mg/l) in various stations of Ashtamudi lake

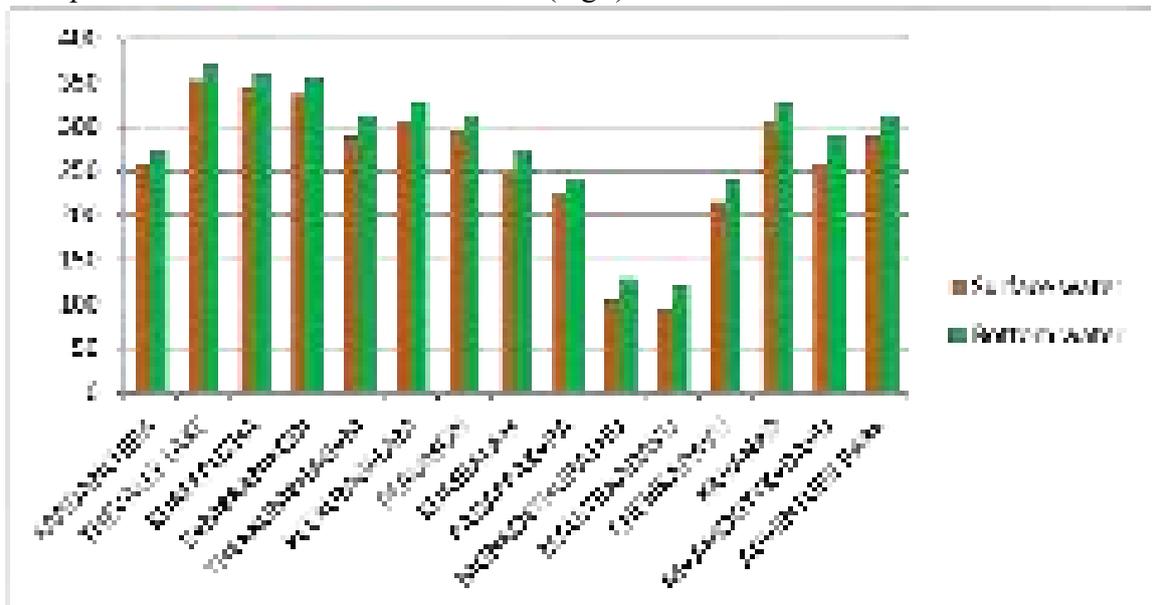
(6) CALCIUM

Graph 6 : Variation of calcium hardness (mg/l) in Ashtamudi lake

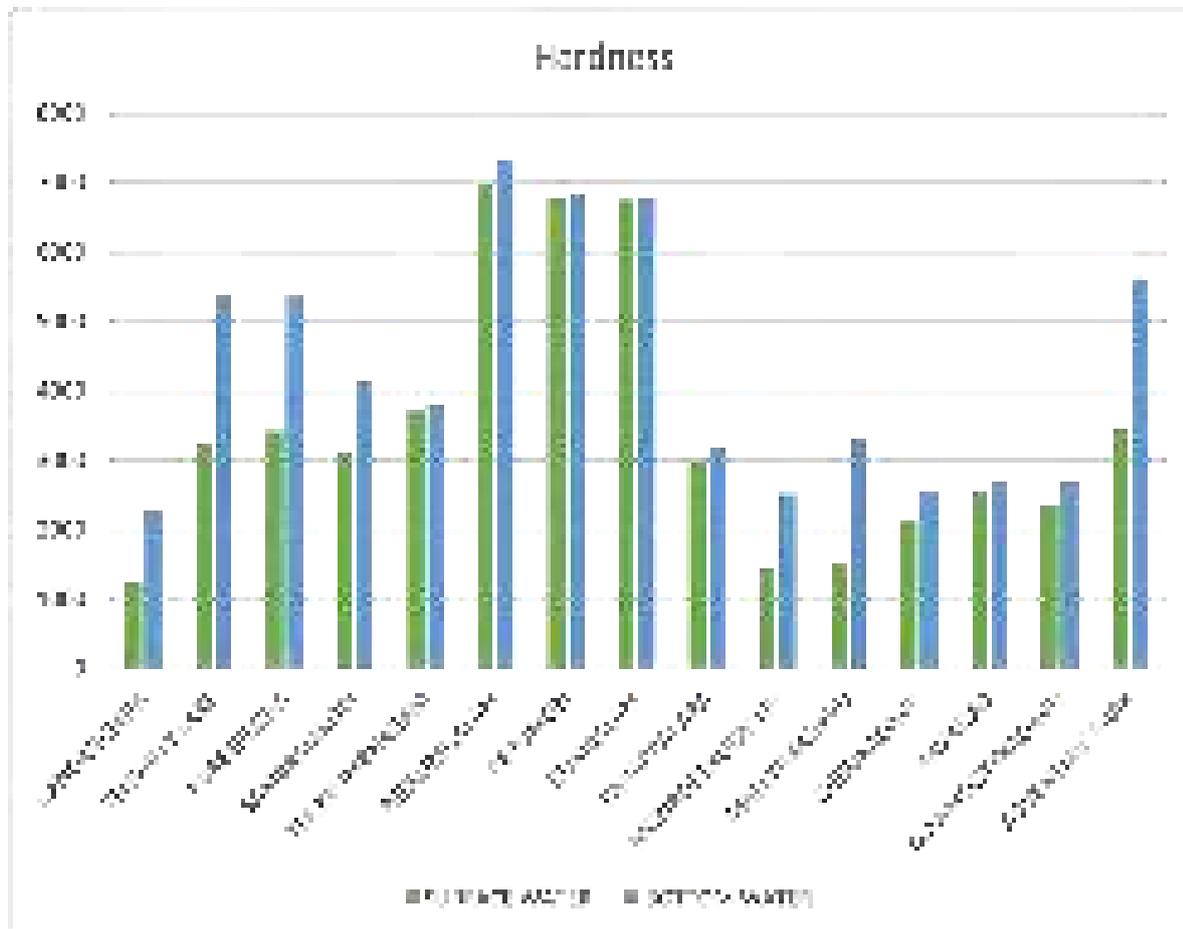
(7) HARDNESS

Total hardness of water is the sum of concentration of alkaline earth metal cations present in it. Hardness is caused by carbonates and bicarbonates and is important for aquatic organisms. Calcium and magnesium are the principal cations imparting hardness. Hardness of water prevents lather formation with soap and therefore hard water is not suitable for bathing and washing. The total hardness value had showed marked variations with respect to different stations of the Ashtamudi Lake. Total hardness of the surface and bottom samples of station S6 (Perungalam) is 6930 mg/L and 7300mg/L respectively which is the highest value obtained among all the stations. The lowest total hardness value is noted down on analysing the surface and bottom sample of the station S1 (Thevally) which is 1240mg/L and 2260mg/L respectively. In this study the hardness values ranged from 1240mg/L to 7300mg/L.

Graph 7: Total hardness in different stations of Ashtamudi lake
